Learning Together

FEEDBACK FROM NEONATAL CLINICAL INCIDENTS

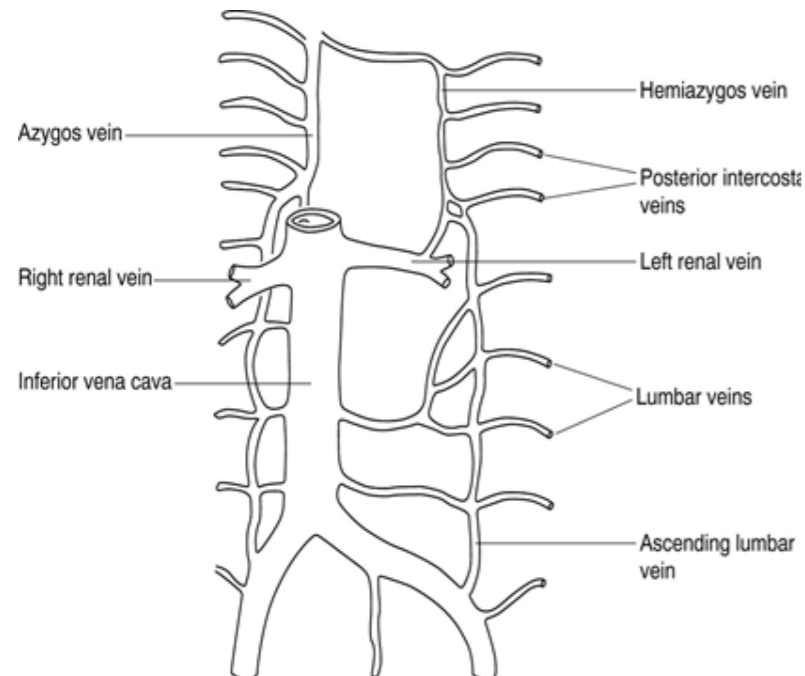
Image 1
Anatomy of left ascending lumbar vein

- These cases highlight a very rare complication of lower limb PICC line insertion
- A PICC line inserted in the left long saphenous vein can enter the left ascending lumbar vein (which runs posterior and parallel to the IVC, image 1) and can then enter the epidural plexus which are small thin walled veins. If vein perforation occurs, fluid from the PICC can enter the CSF and cause neurological damage

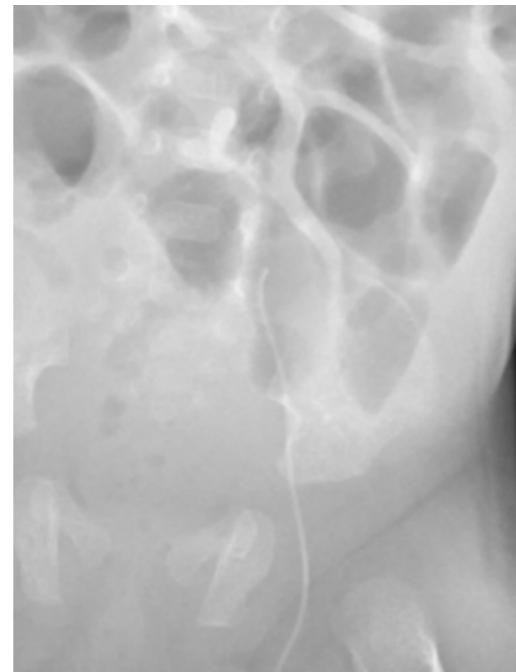
Image 2
A malpositioned PICC line which has not crossed the midline and remains on the left side of the vertebral column

- On AP x-ray to check line position a left saphenous PICC should track from the leg into the abdomen via the left iliac vein. It should cross the midline at L_{4/5} to run on the RIGHT side of the vertebral column in the IVC
- There should be no tortuosity in the path of the PICC line (tortuosity could be a sign it is in a small vessel)
- If a left lower limb PICC does not cross the midline as expected (image 2) or has a tortuous course (image 3), consider a lateral X-ray and discussion with radiology
- In the case of PICC malposition a lateral x-ray will demonstrate posterior deviation of the line towards the vertebral column (image 4)

- The vast majority of cases of this complication have been reported in PICC lines placed in the left long saphenous vein. Where practical and possible consider insertion in other sites prior to using the left leg
- Extravasation of TPN / lipid into the CSF can cause varying neurological signs including irritability, abnormal movements, seizures and hypotonia
- The production of lipaemic fluid (either white "milky" coloured fluid or fluid with a high triglyceride content) from CSF is pathological and should alert clinicians to this rare complication
- Remove a PICC line promptly if this complication is suspected

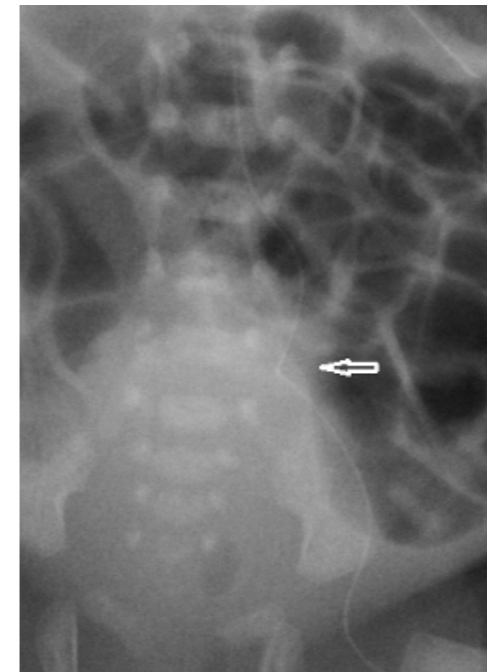
Image 3
A PICC line showing a tortuous course (arrow) and not crossing the midline to run on the right side of the vertebral column

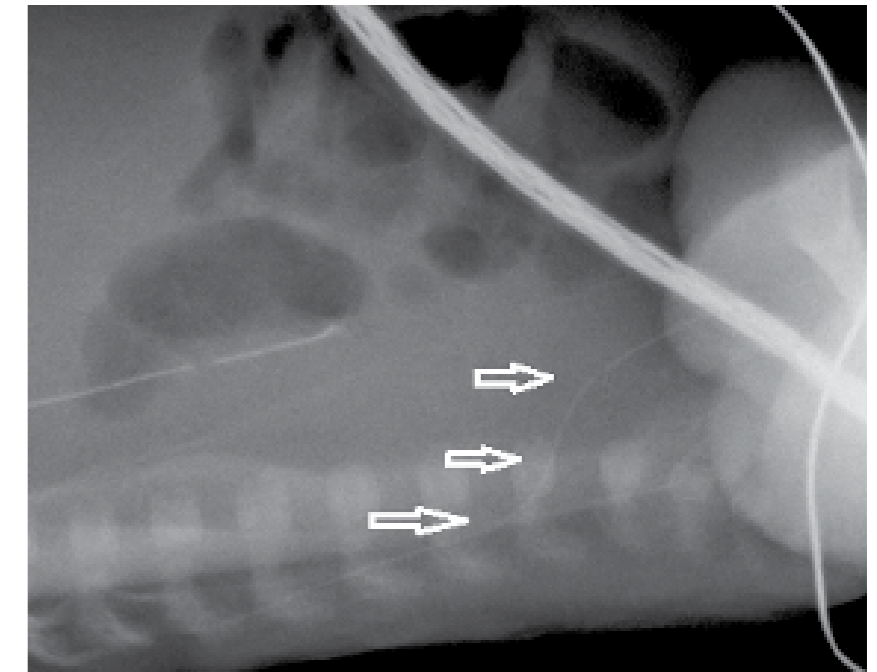
Image 4
A lateral x-ray demonstrating posterior deviation (arrows) of the PICC line towards the vertebral column
